Avnet MicroZed 7020
Revision G Errata
V1.0
26 June 2018

3.1 PUDC_B Pull-up Populated with 0-ohm instead of 1K-ohm

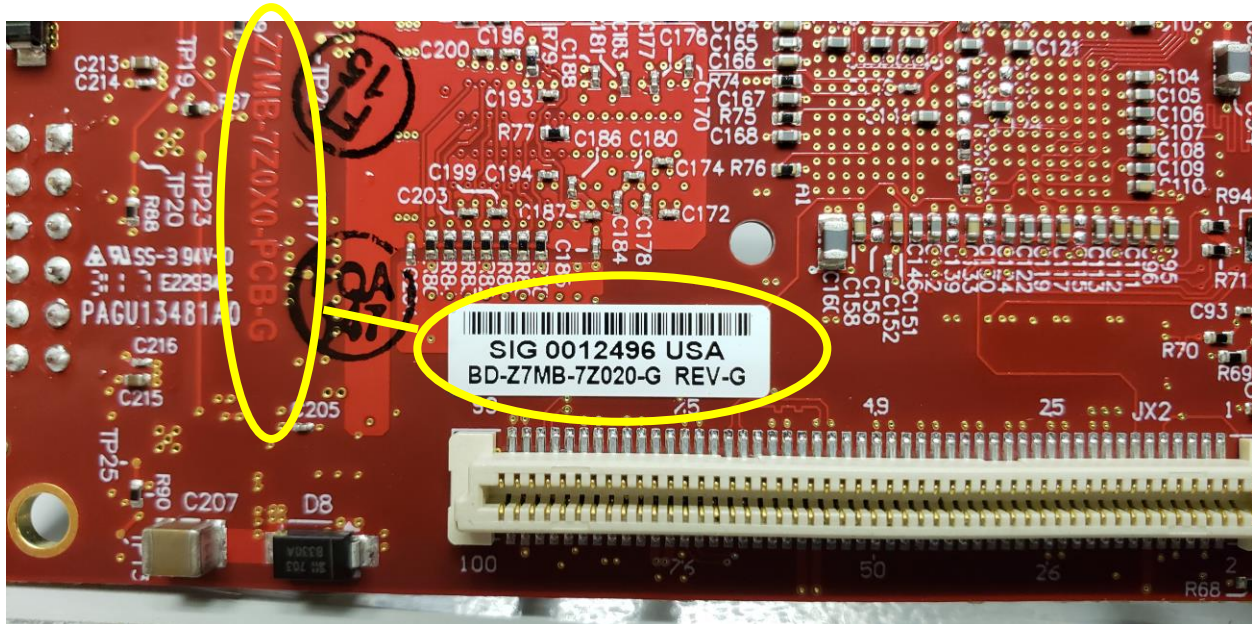
Figure 1 – Identifying MicroZed 7020 for this Errata

The modules affected by these errata can be identified by the Revision of the MicroZed System-On-Module. The revision of the MicroZed System-On-Module can be found on the bottom side of the PCB board. The affected PCB boards are the MicroZed Revision G, identified as PCB assembly number "BD-Z7MB-Z7020-G REV-G" or "BD-Z7MB-Z7020I-G REV-G" with an embedded "PCB-G" also visible in the board etching.

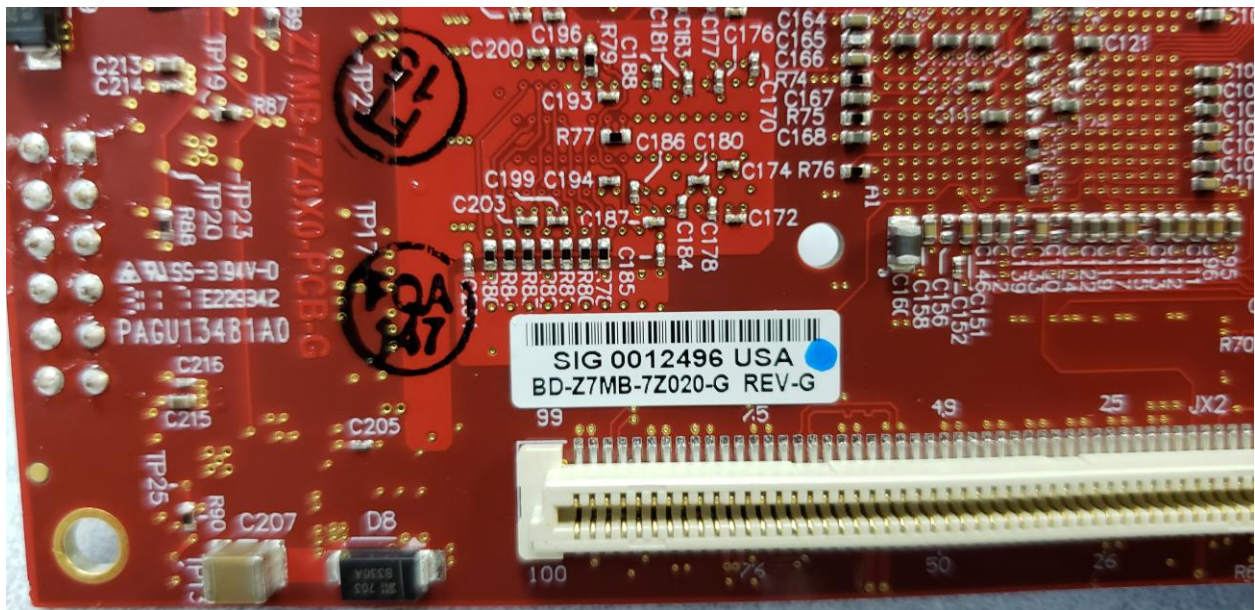
Figure 4 – Repaired MicroZed Rev G Board

A repaired Revision G board that has this workaround in place will be identified with a blue mark on the bar code label as shown below:

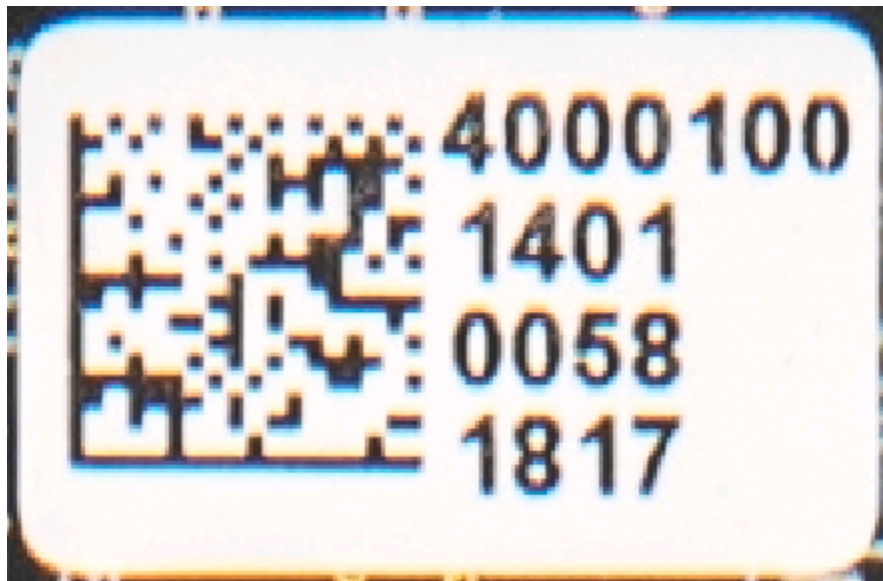
Figure 5 – Example 2D Bar Code for Future Rev G MicroZed Boards
(Note: this is only an example bar code, not from MicroZed)

New Revision G boards with Revision Code G-03-03 or later will have a 2D bar code label similar to the one shown below. These boards do not have the issue.
