**Avnet MicroZed 7020**  
**Revision G Errata**  
**V1.1**  
**02 March 2019**

#### 3.1 PUDC\_B Pull-up Populated with 0-ohm instead of 1K-ohm

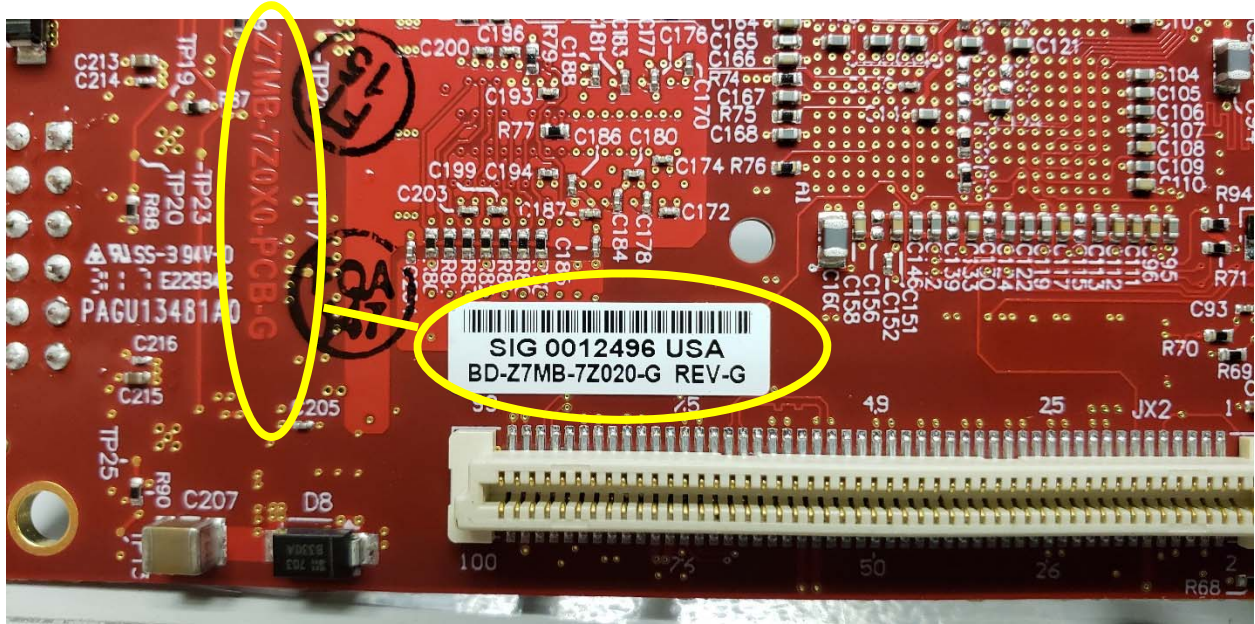
Figure 1 – Identifying MicroZed 7020 for this Errata

The modules affected by these errata can be identified by the Revision of the MicroZed System-On-Module. The revision of the MicroZed System-On-Module can be found on the bottom side of the PCB board. The affected PCB boards are the MicroZed Revision G, identified as PCB assembly number "BD-Z7MB-Z7020-G REV-G" or "BD-Z7MB-Z7020I-G REV-G" with an embedded "PCB-G" also visible in the board etching.

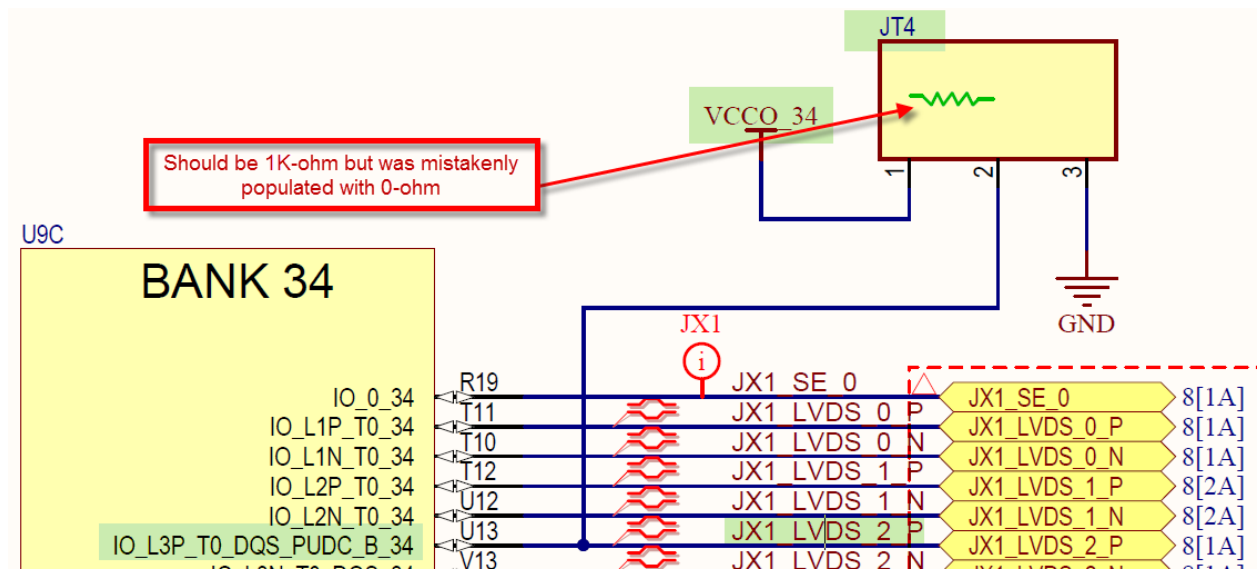
On MicroZed, the PUDC\_B signal is in Bank 34 of the Zynq-7000, Pin U13 on component U9C on Sheet 6 of the schematic document. This pin is tied to schematic signal JX1\_LVDS\_2\_P, which is also tied to resistor jumper JT4 and MicroHeader JX1 Pin 17.

Resistor jumper JT4 is a 3-pad component that allows an 0402 resistor to be placed either in the 1-2 position or the 2-3 position. By default, this was supposed to be populated with a 1K-ohm resistor in the 1-2 position. Unfortunately this was mistakenly populated with a 0-ohm resistor, thus shorting JX1\_LVDS\_2\_P to power supply VCCO\_34. This effectively disables PUDC, but it also makes this I/O unusable.

Figure 2 – JT4 Pull-up Connected to PUDC\_B, JX1\_LVDS\_2\_P, and JX1-Pin17

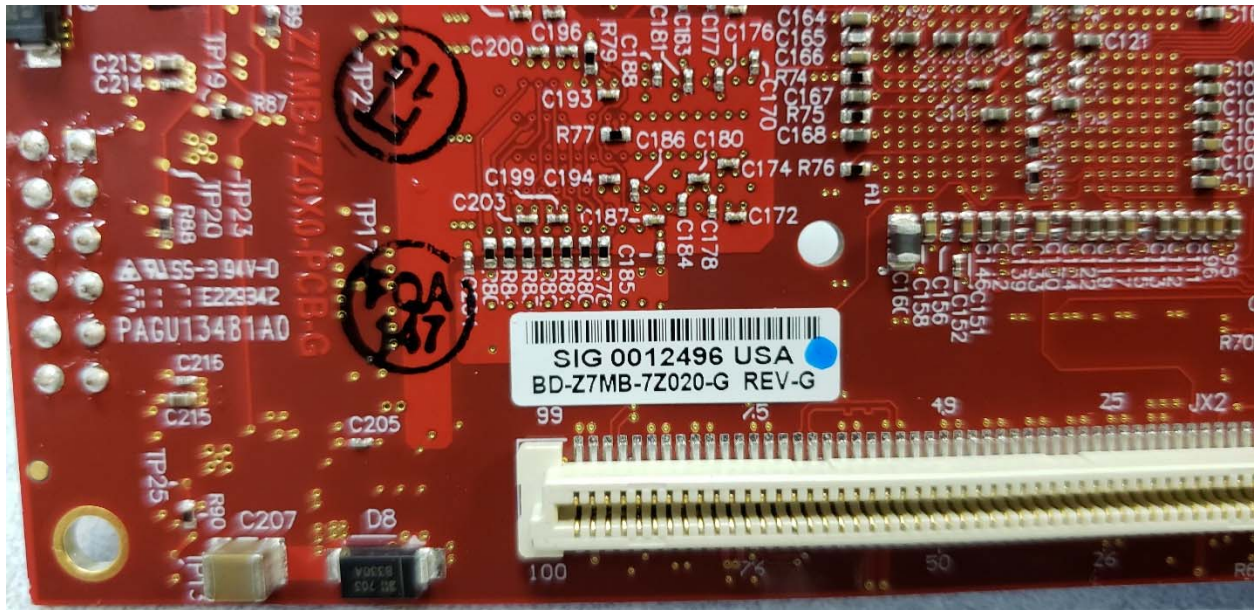
A repaired Revision G board that has this workaround in place will be identified with a blue mark on the bar code label as shown below:

Figure 4 – Repaired MicroZed Rev G Board

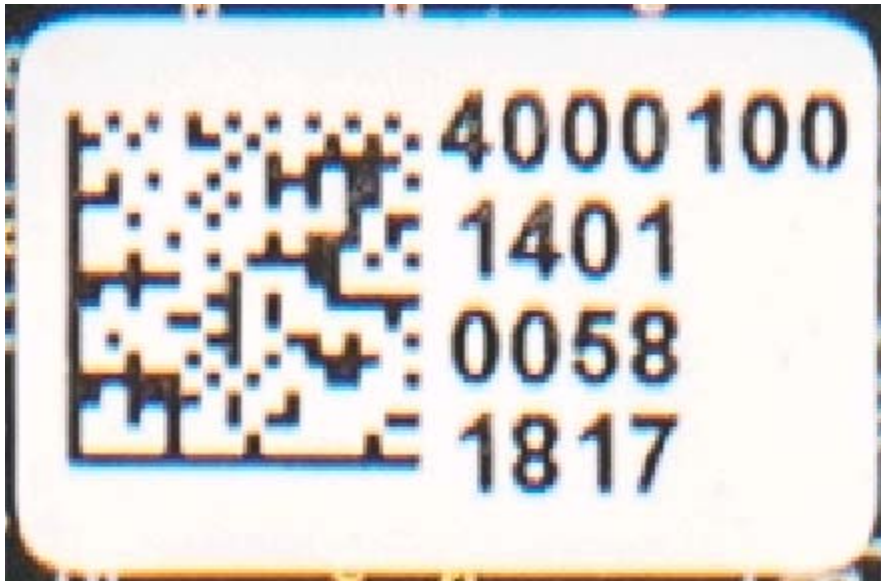
New Revision G boards with Revision Code G-03-03 or later will have a 2D bar code label similar to the one shown below. These boards do not have the issue.

Figure 5 – Example 2D Bar Code for Future Rev G MicroZed Boards  
(Note: this is only an example bar code, not from MicroZed)

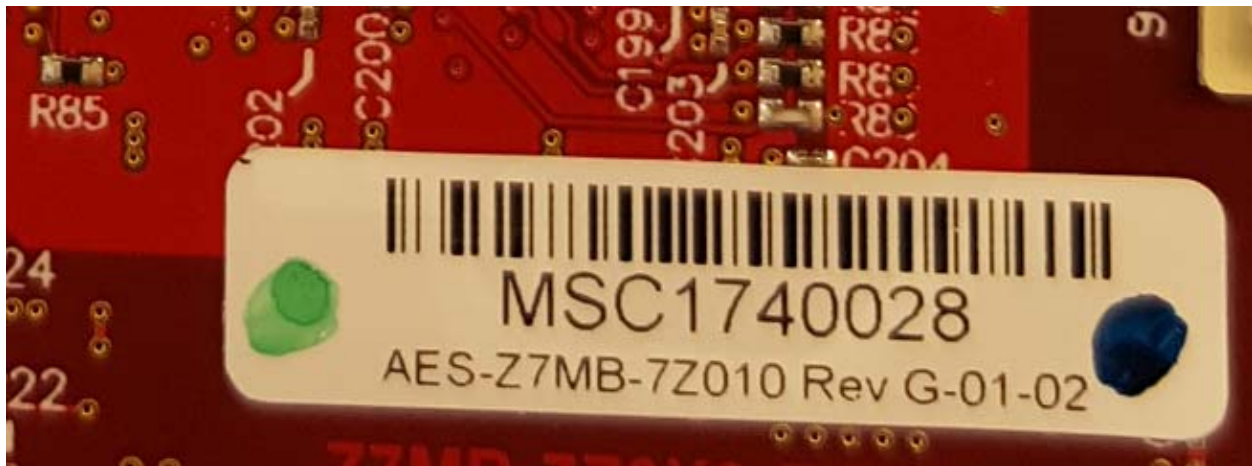
LED D3 was placed backwards during assembly and will therefore not operate properly. Once the LED is resoldered in reverse position, it will operate correctly.

A repaired Revision G board that has this workaround in place will be identified with a green mark on the bar code label as shown below. See 3.1 for an explanation regarding the blue mark on the right side.

**Figure 6 – Repaired MicroZed Rev G Board**
