PicoZed FMC Carrier Card Revision C Errata

Thank you for your interest in the PicoZed FMC Carrier Card (PZCC-FMC). Although Avnet has made every effort to ensure the highest possible quality, these boards are subject to the limitations described in this errata notification. This document pertains to the PicoZed FMC Carrier Card Revision C.

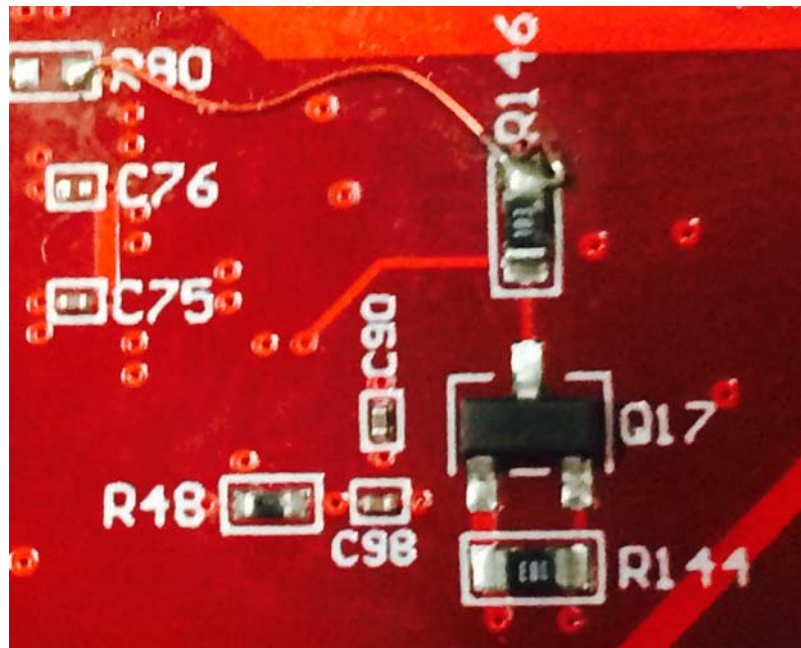
Figure 2 – Rework which changes Ethernet Port J11 to Address 0x01

4.1 Ethernet Address conflict on SOM and Carrier Card

The secondary Marvell 88E1512 PHY on PicoZed FMC Carrier sets the PHY's MDIO address to 0, which is the MDIO broadcast address. Since the Xilinx GMII-to-RGMII shim is also on the MDIO bus, the shim could potentially interfere with communication to the PHY (although the shim does not respond to the broadcast address as of Vivado 2014.4).

Remove R80. Wire the top of R146 to the right pad of R80. This changes the PHYAD[0] from a '0' to a '1'.
