Avnet UltraZed-EV Carrier Card

Revision 1 Errata

03 February 2020

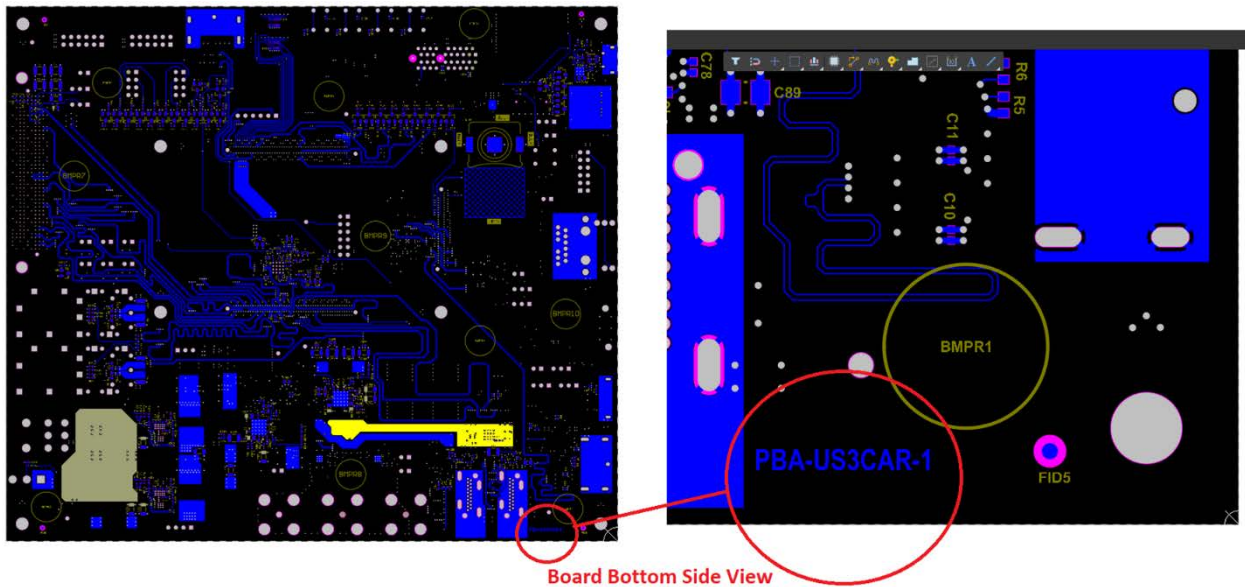
The carriers affected by this errata can be identified by the PCB Name of the UltraZed-EV Carrier Card. The PCB Name of the UltraZed-EV Carrier Card is written in copper and can be found on the bottom side of the board near the edge on the backside to the RIGHT of the HDMI connectors along the same edge. This assumes you are looking at the BACK of the carrier card with the 3G-SDI connectors facing the direction depicted in the below figure.

The current production revision is "1-01-03". Any boards that are at this revision or earlier are affected. Any board with a "1" at the end of the string (PBA-US3CAR-1) is an affected board.

The earliest next revision of this board will be "2-01-00". Using the same identifying techniques listed above in "Identifying Affected Modules," any board that begins with "2" or greater will have the PCB copper correction. These boards will be easily identified by the metal on the bottom side of the PCB that reads "PBA-US3CAR-2"
